# ***Energia Multivalve Model EN02***

## Multivalve description

The Energia multivalve model EN02 is a component for LPG gas systems designed according to the UN ECE R01 67 Regulation and approved by the Ministry of Transport of the Czech Republic with approval number E8-67R013018.

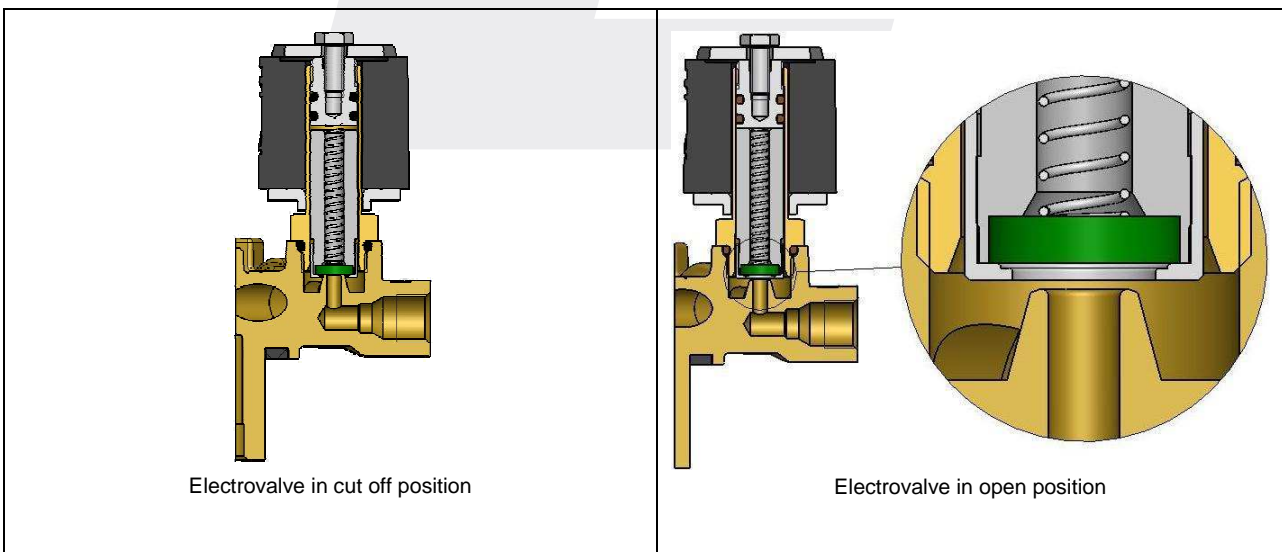
**e) Shut-off solenoid valve**

This device is aimed stop the gas flow when one of the following conditions occurs: the engine is switched off or is working in petrol and the electric supply to the solenoid is switched off; in this condition, a spring inside the solenoid valve maintains the moving core in the closing position; while switching to LPG, the electric supply to the solenoid is switched on and the solenoid generates a magnetic field that attracts the plunger, allowing the opening of the multivalve hole and, consequently, the LPG flow.

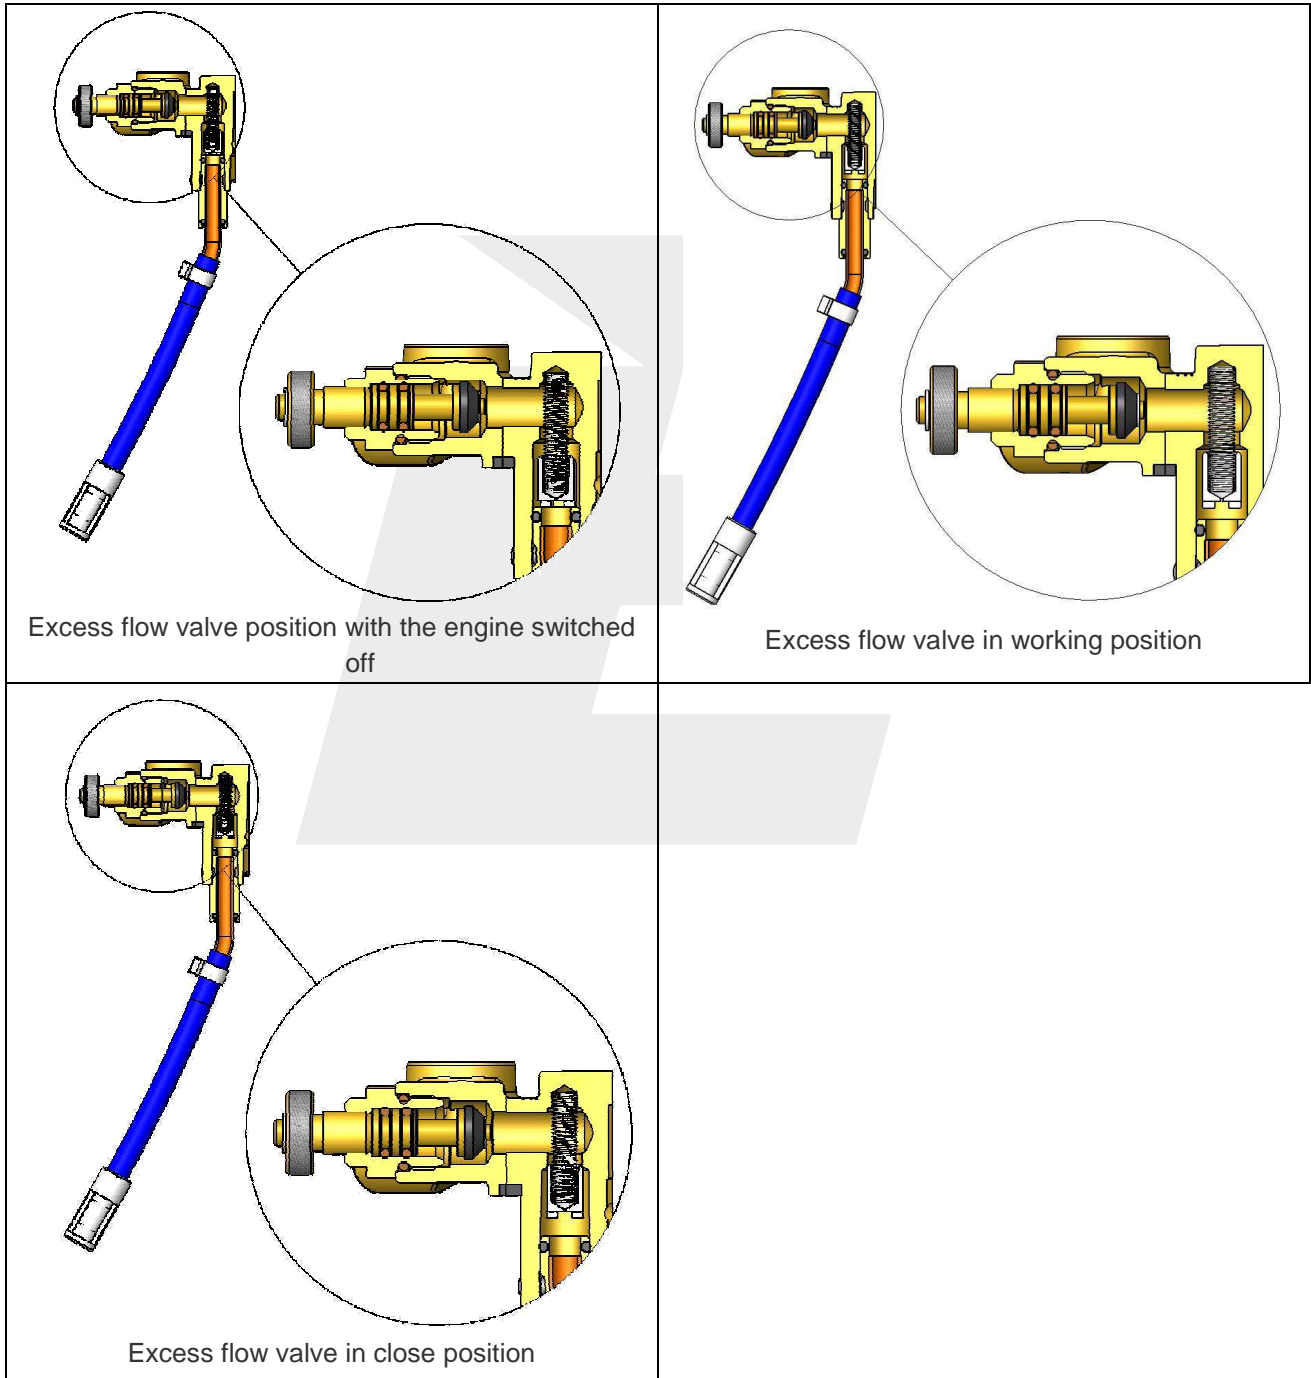
**f) Excess flow valve**

The excess flow valve is located in the withdrawal circuit , upstream the solenoid valve and is aimed to block the flow of LPG in the event of an accidental breakage of the LPG piping . After its intervention, for the automatic resetting of the valve, a residual flow is allowed.

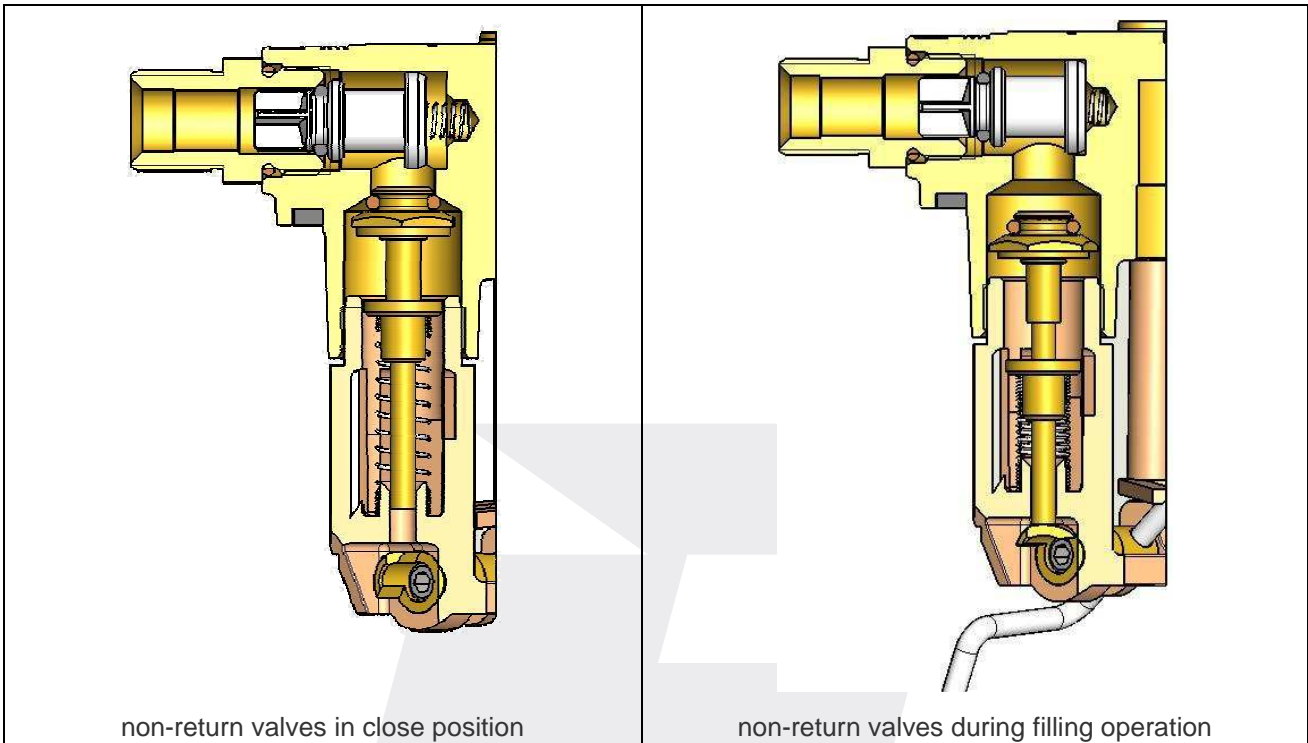
**g) Non-return valve at the inlet**

The non-return device is equipped with a double safety system: the first non-return valve is integrated in the 80% filling limiter, the second device is located in the inlet fitting. These devices are aimed to avoid the back flow of gas from the tank toward the outlet of the filling device

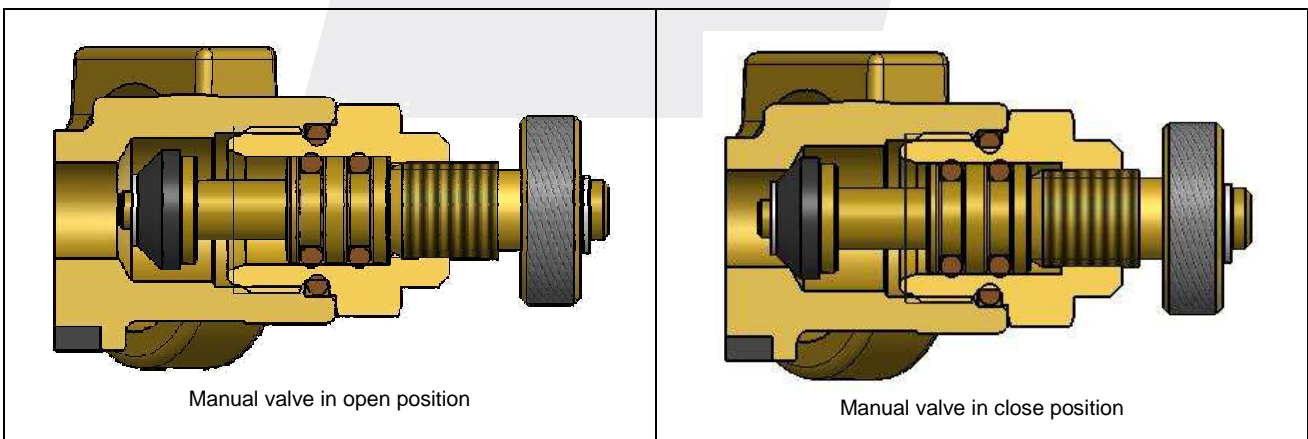
**h) Manual valve**

The manual valve intercepts the outlet gas circuit upstream of the solenoid valve and is aimed to the maintenance of the solenoid valve.

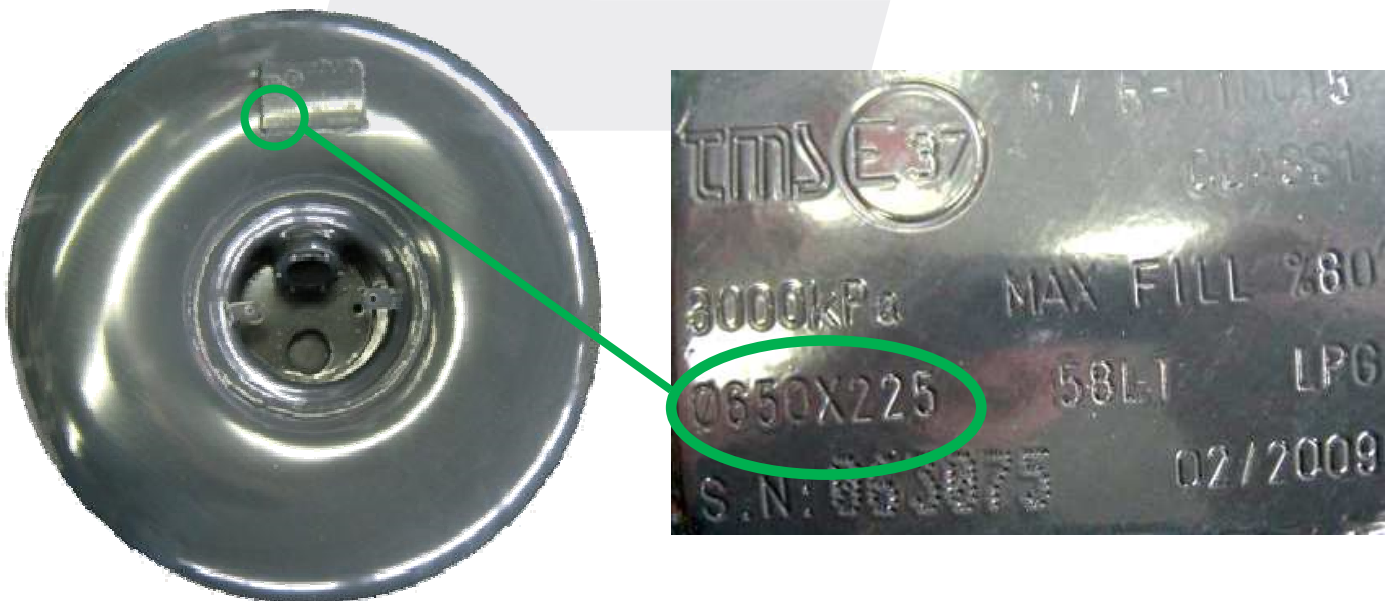
Figure 2: LPG tank size

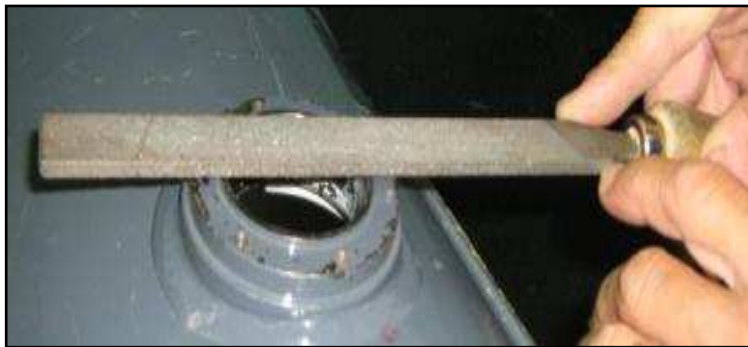
The seat ring has to be clean and any remaining paint has to be removed, taking care to not create planarity error, dents or scratches that might affect the sealing. The inside part of the tank has to be cleaned from any

welding or sanding residue and empty from any trace of water (see figure 4).

**Figure 4: Removing of the paint from the seat ring of the tank**

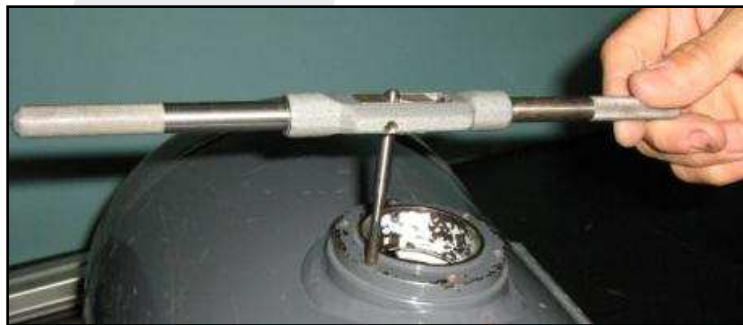
If necessary, residual paint from the screw threaded holes M5 has to be removed, as well as any burr or debris created by this operation (see figure 5).

**Figure 5: Removing of the paint from the screw threaded holes**

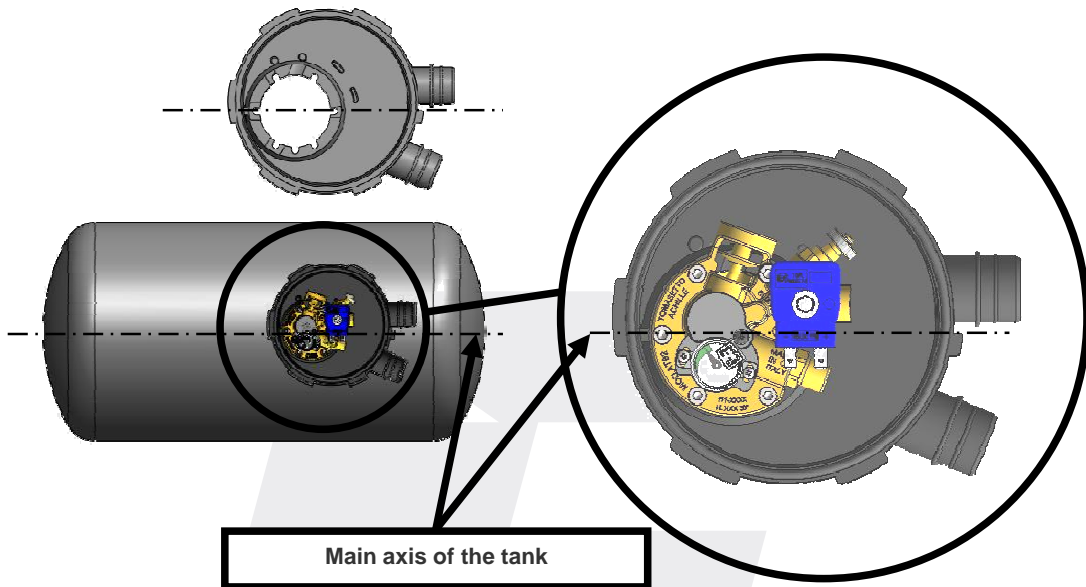
Figure 8: Assembly lay out for 0° and 30° cylindrical tanks

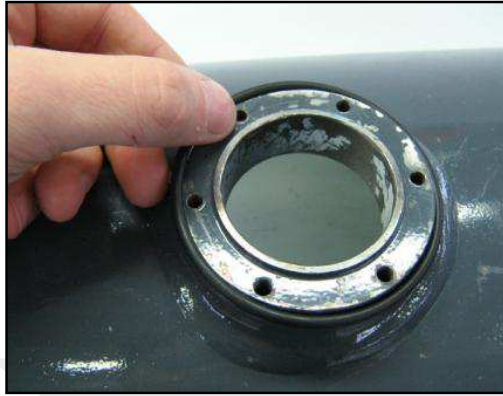
**e) Assembly instructions for 0°, 30° and 90° cylindrical tanks:**  
Placement of the O-ring gasket in the ring of the tank;

Figure 11: Placement of the O-ring gasket

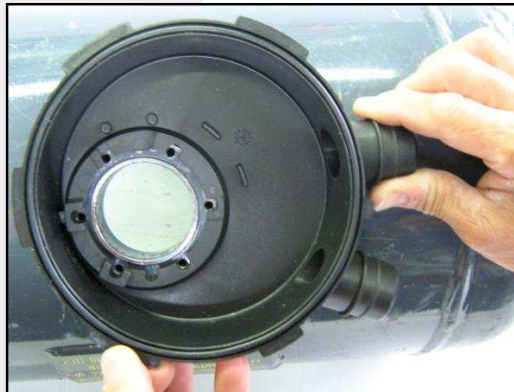
Placement of the gas-tight housing (Figure 12);

Figure 12: Positioning of the gas tight housing

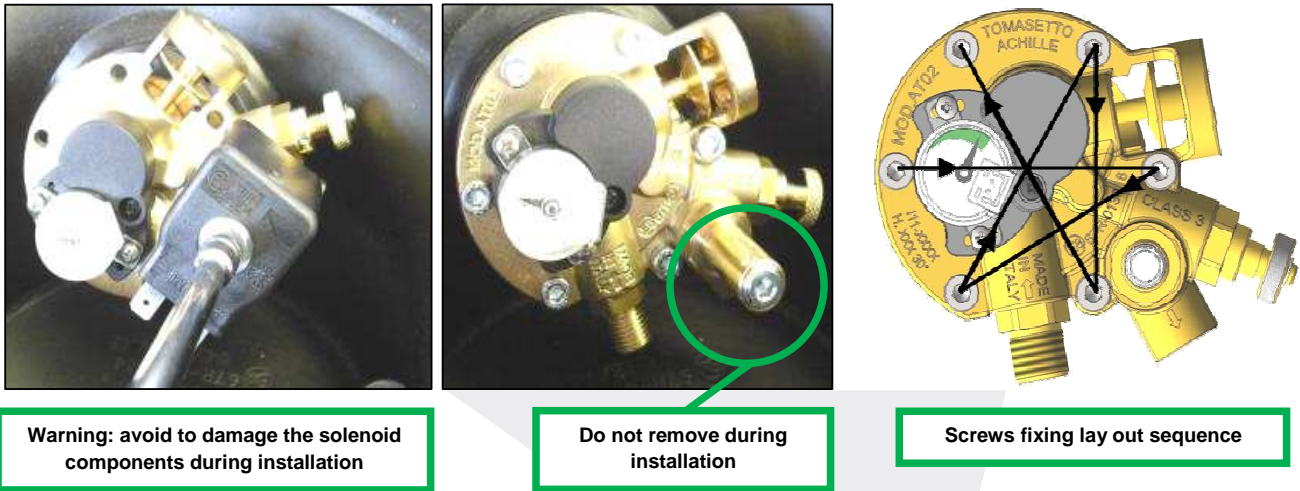
Removal of the coil with a 7mm wrench and fixing of the 6 flange screws (sequence explained in figure 14)  
 Fixing torque to be 3.5 +/- 0.5 Nm

Figure 14: operation sequence for screws fixing

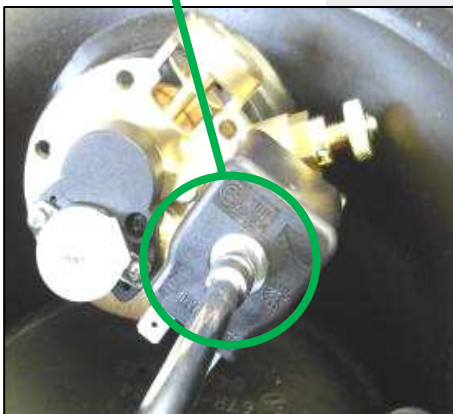
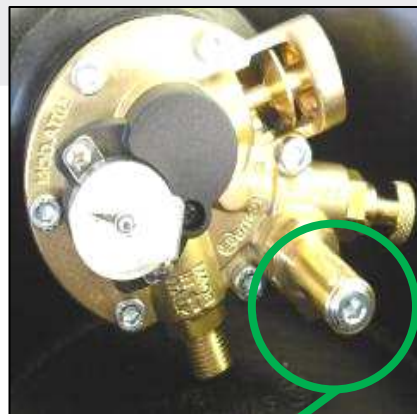
Removal of the coil with a 7mm wrench and fixing of the 6 flange screws (sequence explained in figure 19)  
 Fixing torque to be 3.5 +/- 0.5 Nm.

**Screws fixing lay out sequence**

Figure 19: operation sequence for screws fixing

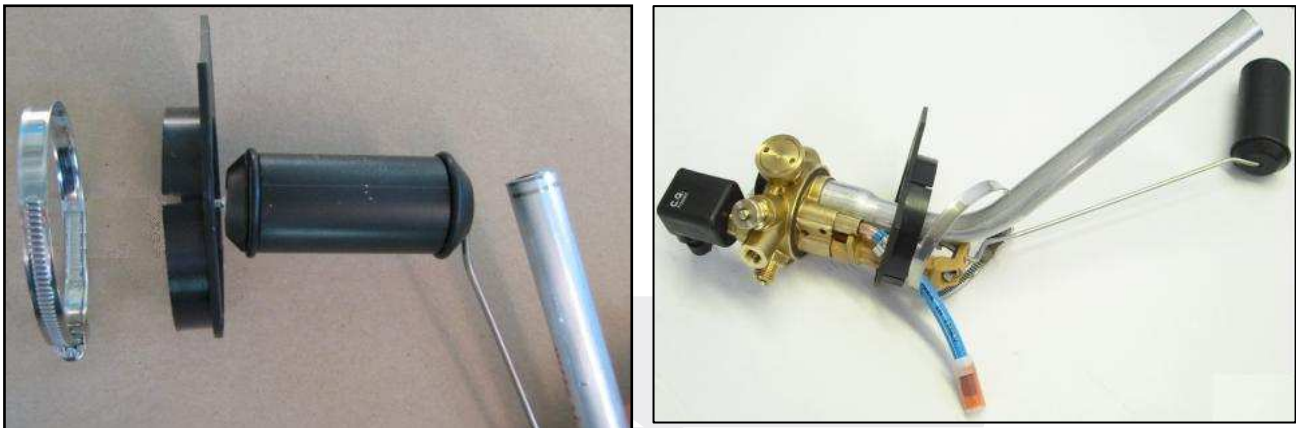
Figura 21:

Inserting of the float rod and of the PRV withdrawal pipe in the plastic ring and clamping (figure 21).

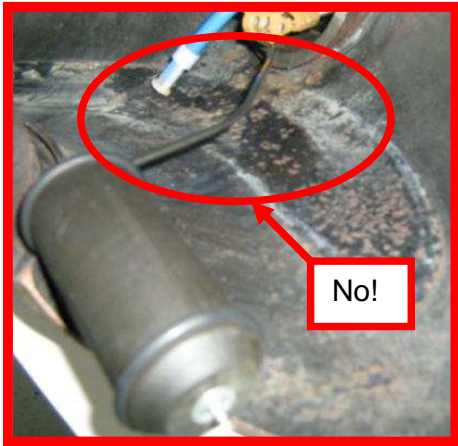
**Warning. To avoid damages to the plastic pipe and guarantee the correct working of the 80% system, the plastic pipe must not be assembled in the tank as shown in figures below**

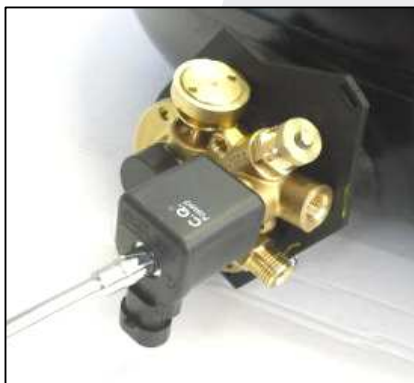
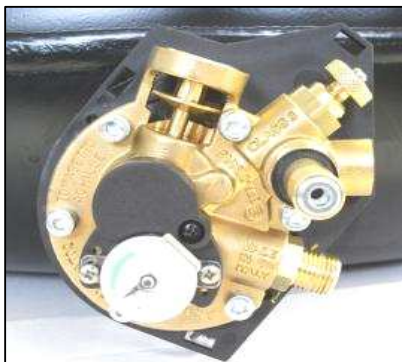
Removal of the coil with a 7mm wrench and fixing of the 6 flange screws (sequence explained in figure 23)  
 Fixing torque to be 3.5 +/- 0.5 Nm.

**Warning:** during the coil assembly operation, insert the gasket and plastic cap to increase the coil protection, to prevent damages caused by water and debris.

Figure 23 operation sequence for screws fixing

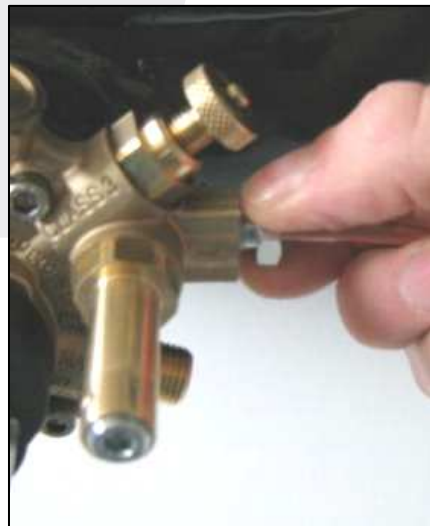
Manual connection of the nut, ferrule and copper pipe to the multivalve outlet fitting;

**Figure 25: outlet fitting manual connection**

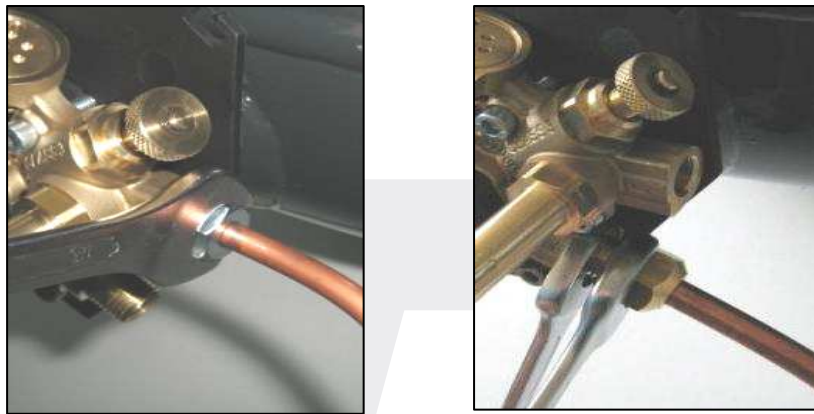
Copper pipes inserting (to be performed with appropriate fittings) in the gas tight housing and manual screwing in the multivalve seat.  
Inlet fitting (17 mm and 16 mm wrenches) outlet fitting pipes fixing (13 mm wrench) (Figure 37).  
Maximum screwing torque to be 5 Nm

**Figure 37: inlet and outlet fittings screwing 0° toroidal tank**

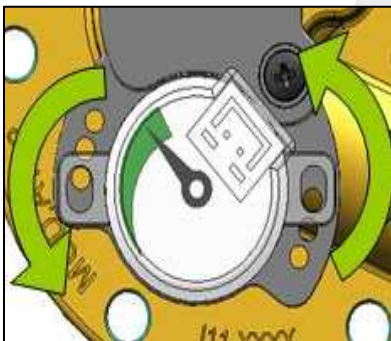
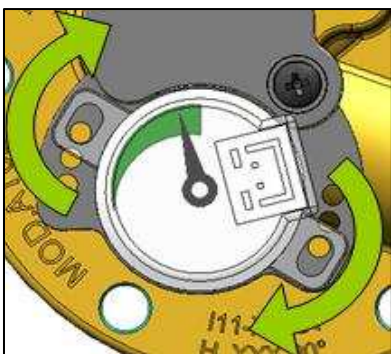
LPG level sensor indication setting (if required): to modify the level sensor setting, the holes on the plastic sensor holder has to be used.

Level sensor to be rotated anticlockwise in case the LPG/petrol switch doesn't switch on the full LED.

Level sensor to be rotated clockwise in case the LPG/petrol switch doesn't switch on the empty LED.

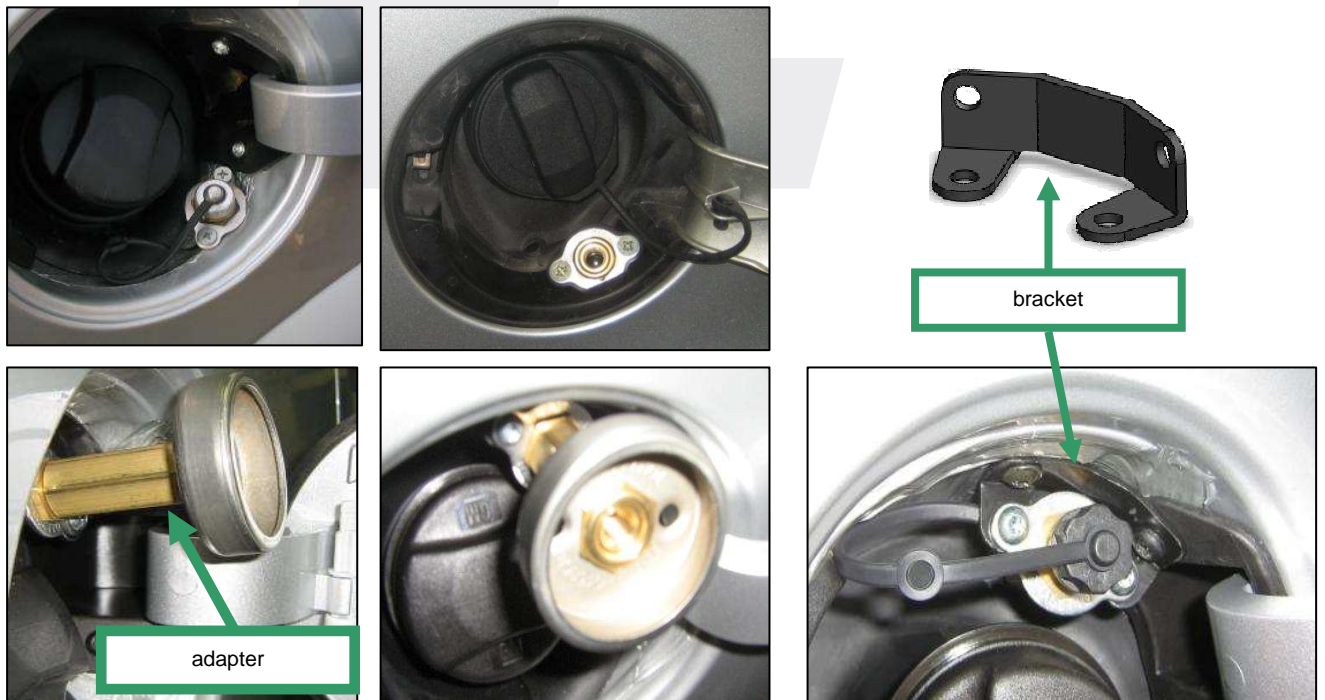
It is recommended to install the filling point in an appropriate area in order to facilitate the operations during the filling.  
 It is recommended to install the filling valve in an appropriate area free from water and debris.  
 It is recommended to install the remote filling point in an appropriate position suitable to hold different filling adapters..

**Figure 39: filling point installation**
